Rescue and restoration

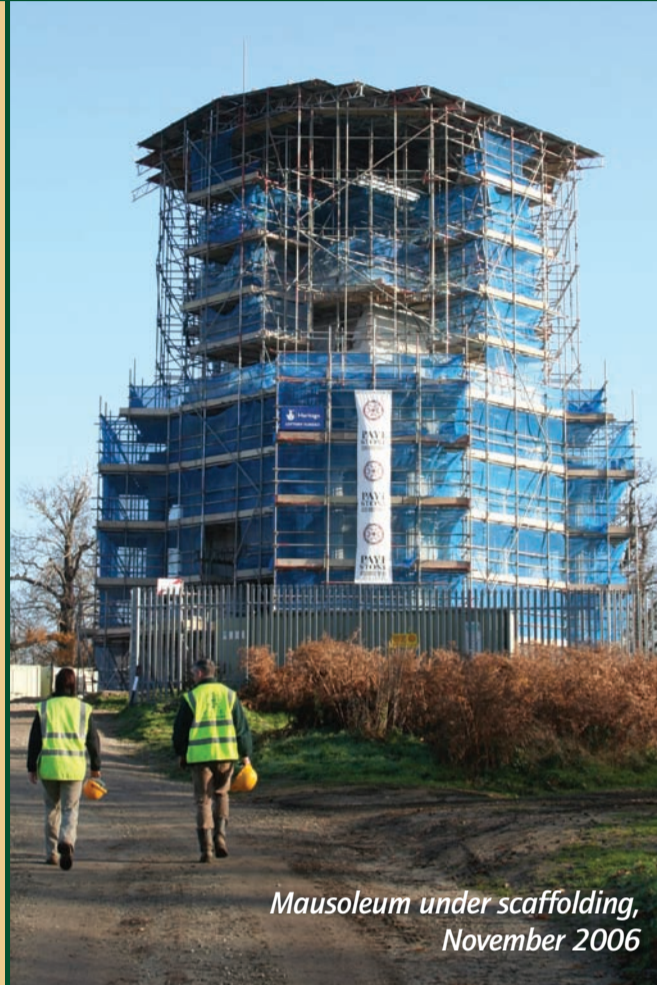
Mausoleum under scaffolding, November 2006

The first task was to encase the structure entirely in scaffolding, with further internal scaffolding to provide access right up to the chapel ceiling. It was then possible to carry out the process of full external and internal cleaning.

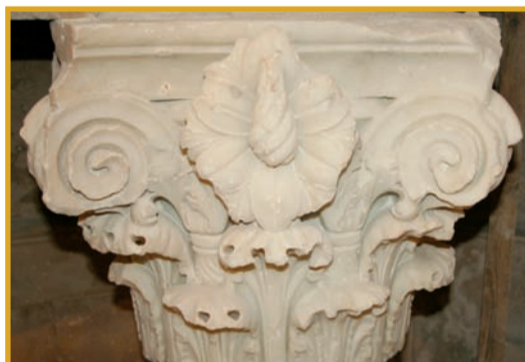
Cleaned marble capital on chapel column

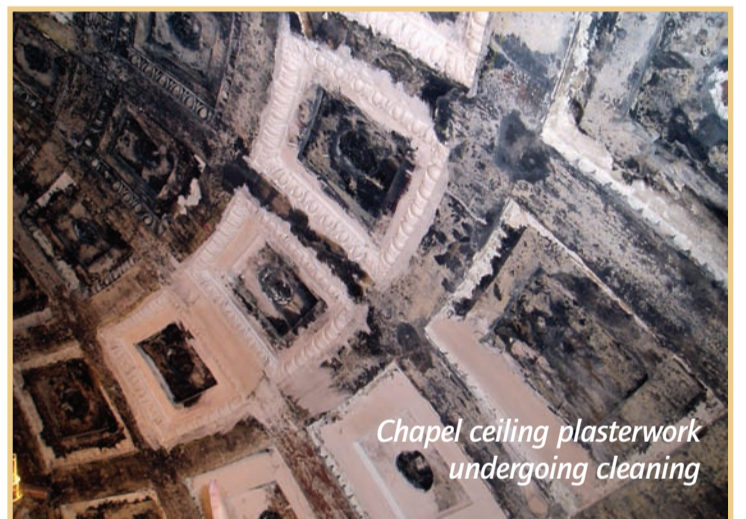
Chapel ceiling plasterwork undergoing cleaning

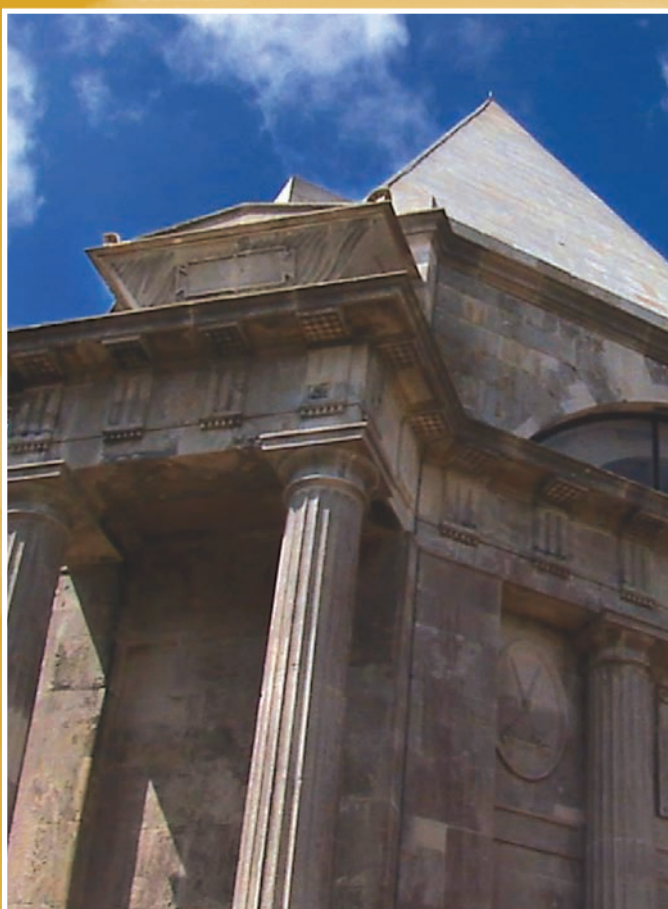
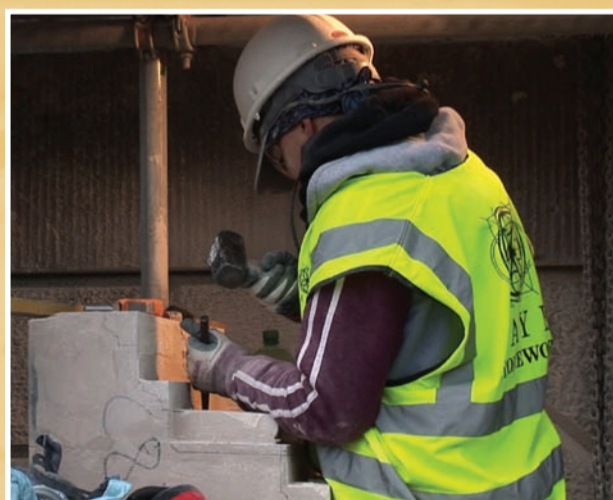
External stonework

The Mausoleum stonework had been damaged by vandalism and natural weathering. Where necessary, stonework has been replaced or indented (existing damaged stone being cut to make way for accurately carved replacements).

Corrosion of iron cramps, used to hold the stone together, had also resulted in stone damage, particularly to the pyramid; vegetation had then exploited gaps in the stonework and pushed the stones out of position. Where necessary, these cramps have been replaced with stainless steel and resealed with lead to ensure that the future integrity of the structure is maintained.
